INADEQUATE TRAY ADHESION

DE-LAMINATION/LACK OF CO-ADAPTATION

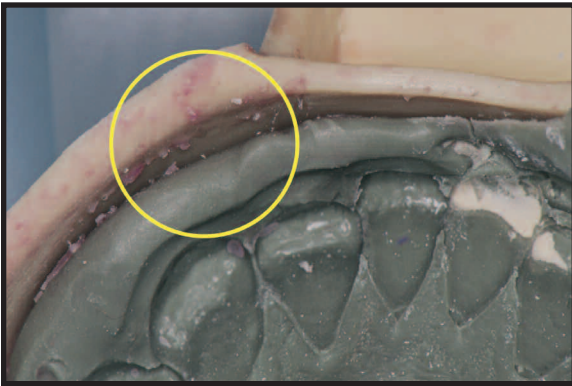
- Tray adhesive not used or applied properly.
- The impression material can shrink away from the tray causing distortion that results in a reproduction smaller than the tooth.
- The tray is no longer supportive of the impression material and distortion could result upon pouring.

- Use tray adhesive recommended by manufacturer.
- Apply one thin even coat of adhesive to tray covering all areas of contact between tray and impression material.
- Allow 5 minutes to dry.

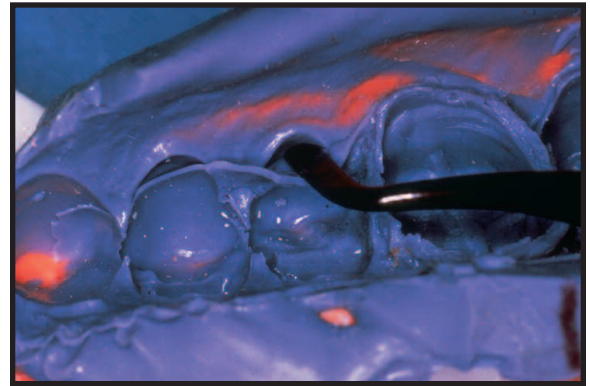
- Timing of wash and tray materials not synchronized.
- Material not setting.
- Latex contamination.
- Provisional residual from oxygen inhibition layer.
- Blood/saliva/water contamination especially with a two step technique when a spacer is not used.
- Relining of impression with wash material.

- Seat Regular Set material within 1 minute 10 seconds and Fast Set material within 35 seconds.
- Use a spacer for Two Step techniques.
- Latex gloves should not touch material.
- Ensure proper isolation.
- Do not use the same impression in a two step technique for the provisional matrix and the final impression.
- Do not reline.

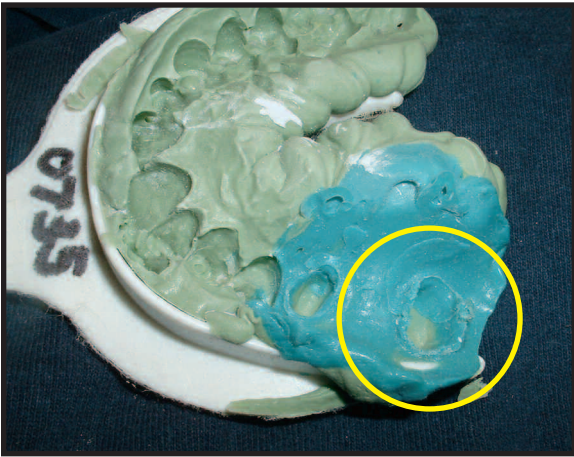
DO NOT RELINE

Relining is not an option as it does not provide proper co-lamination and will distort the impression.
